**NASA Contractor Report 178409**

## **Composite Transport Wing Technology Development**

Douglas Aircraft Company  
McDonnell Douglas Corporation  
Long Beach, CA 90846

**Contract NAS1-17970  
February 1988**

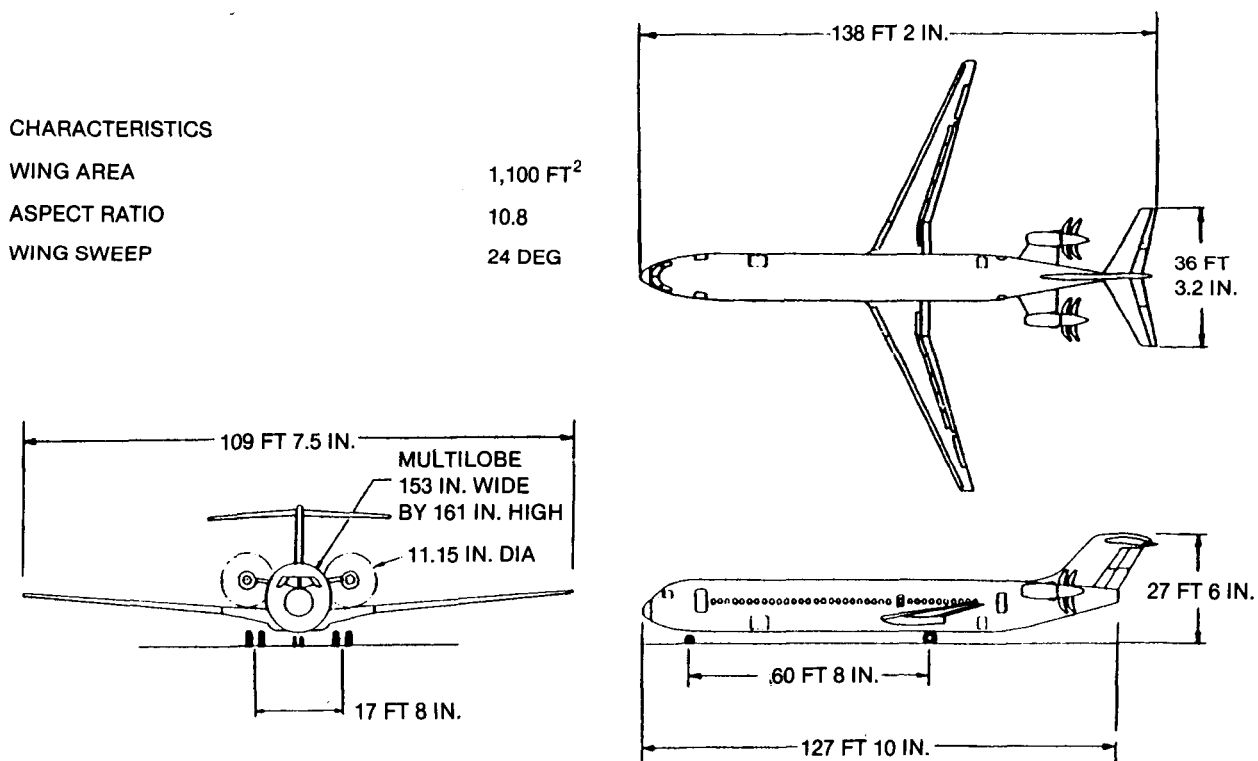
**Figure 1. D-3304-2 Baseline Aircraft**

Douglas selected a baseline transport aircraft (Figure 1) with the advanced engineering designation D-3304-2 for the composite wing technology development program. The vehicle considered is an intermediate-range, 150-passenger commercial transport aircraft with propfan engines, planned for introduction into airline service in the mid-1990s. Its high-technology wing (Figure 2) features a supercritical airfoil and a high-aspect ratio for low-drag performance. Design integration studies previously conducted by Douglas indicated that synergistic benefits can be achieved to reduce both drag and structural weight when high-aspect-ratio wings are constructed of lightweight advanced composite materials.

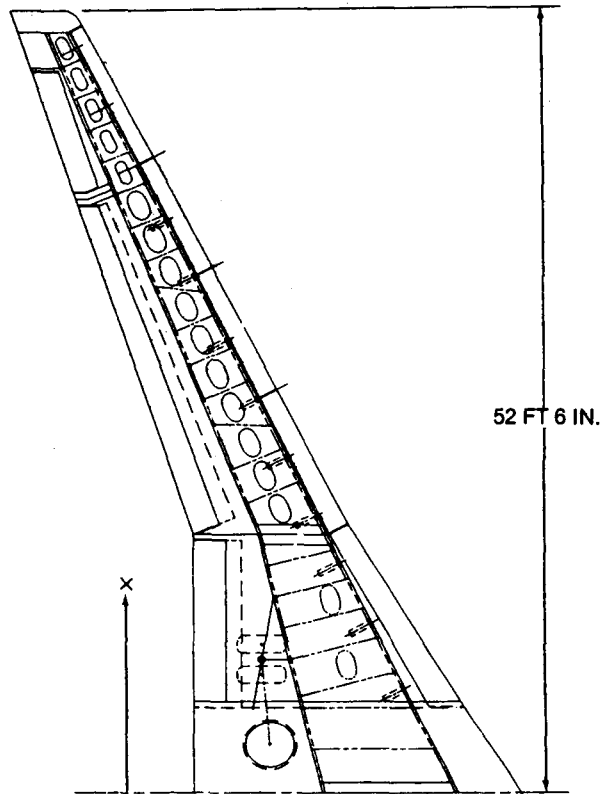
**Figure 2. Baseline Wing Structural Arrangement**

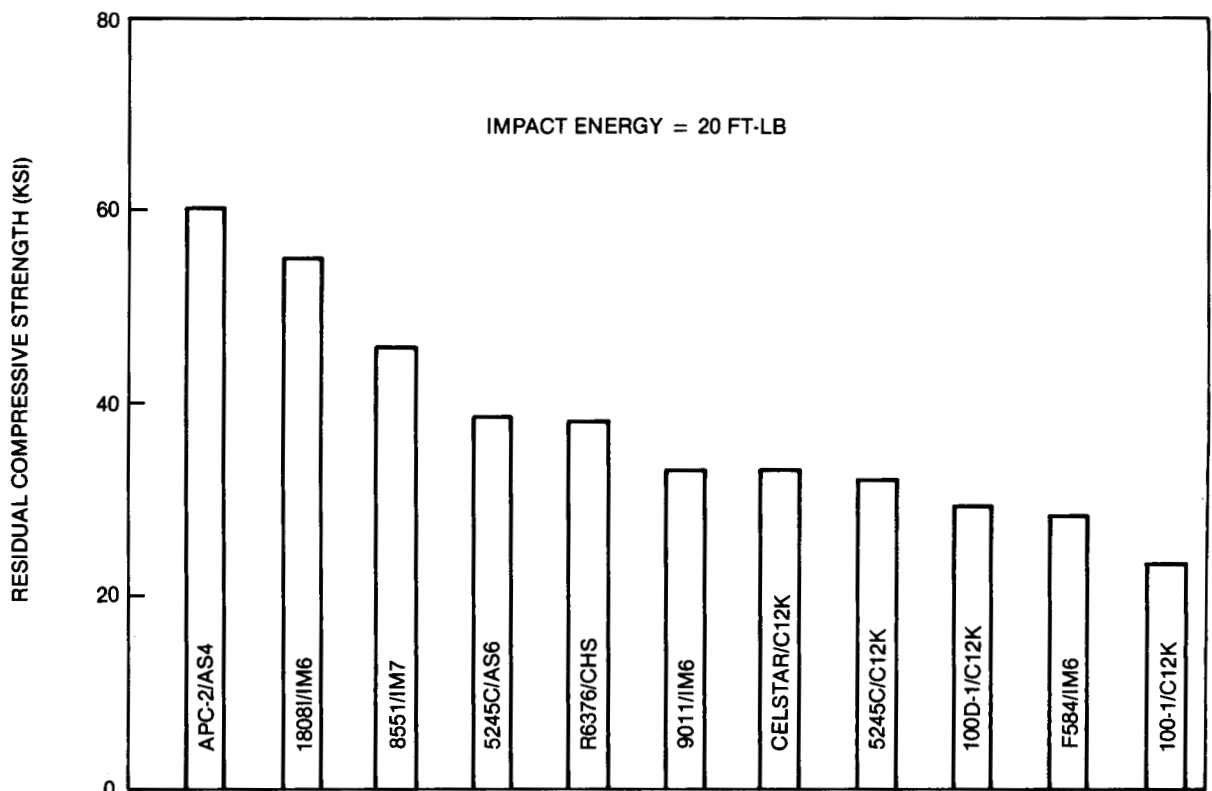
**Figure 3. NASA ST-1 Tests — Residual Strength (Room Temperature, Dry)**

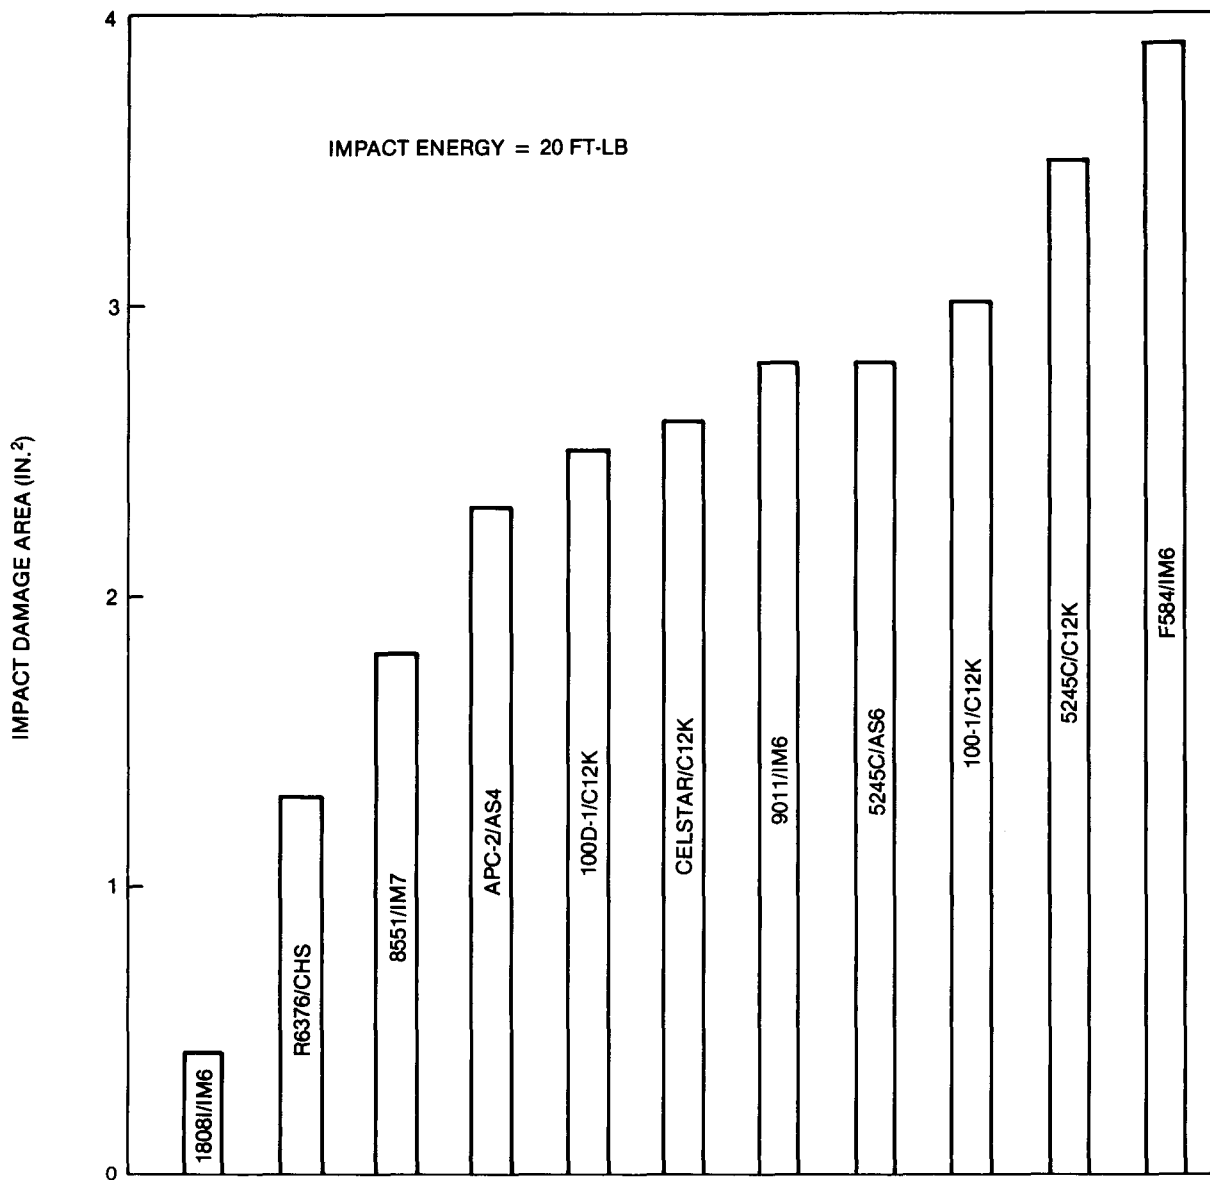
Figure 4. NASA ST-1 Tests — Impact Damage Size (Room Temperature, Dry)

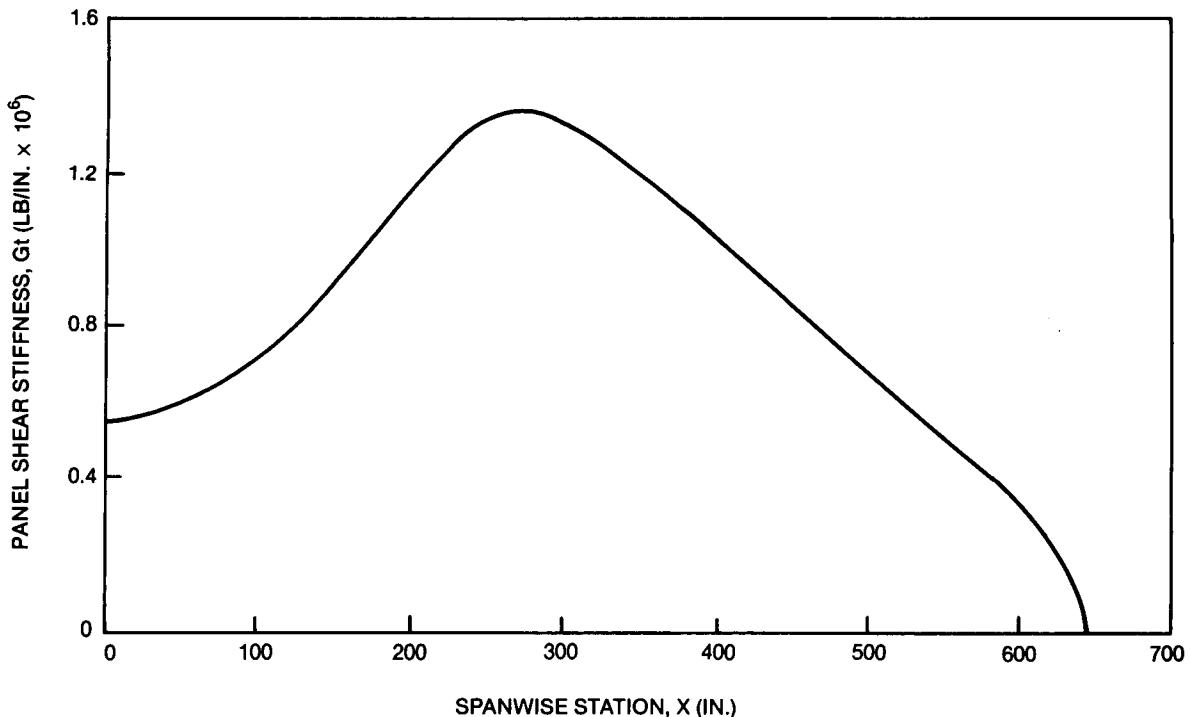
Figure 6. Wing Box Shear Stiffness Requirement

The stiffness distribution requirements for the high-aspect-ratio wing of the D-3304-2 are shown in Figures 6 and 7. For this stiffness-critical design, if aeroelastic effects are not considered, the structural weight is purely a function of the extensional modulus of the cover panels. Therefore, the cover skin stacking sequence was selected as the highest possible percentage of 0-degree plies that would not adversely affect the repairability of the structure. High percentages of 45-degree plies were also desirable to meet torsional stiffness requirements. Ultimately, a (0/45/0/-45/0/45/0/-45/90) pattern was selected as a baseline (see Figures 8, 9, and 10), and a design strain of 4,500  $\mu$ in./in. was established. These curves result from tailoring the laminate while keeping the approximate percentage of plies the same.

In general, stringer spacing is a function of extensional ( $E_t$ ) stiffness as shown in Figures 6 and 7. The stringer spacing of 7 inches was decided by realistic design constraints and resulted primarily from the requirement for large access doors along the span. Since the doors are roughly 12 inches wide, only one cut stringer at each door is required. A panel with wider spacing would not carry adequate load, while a panel with narrower spacing would require two cut stringers at each cutout.

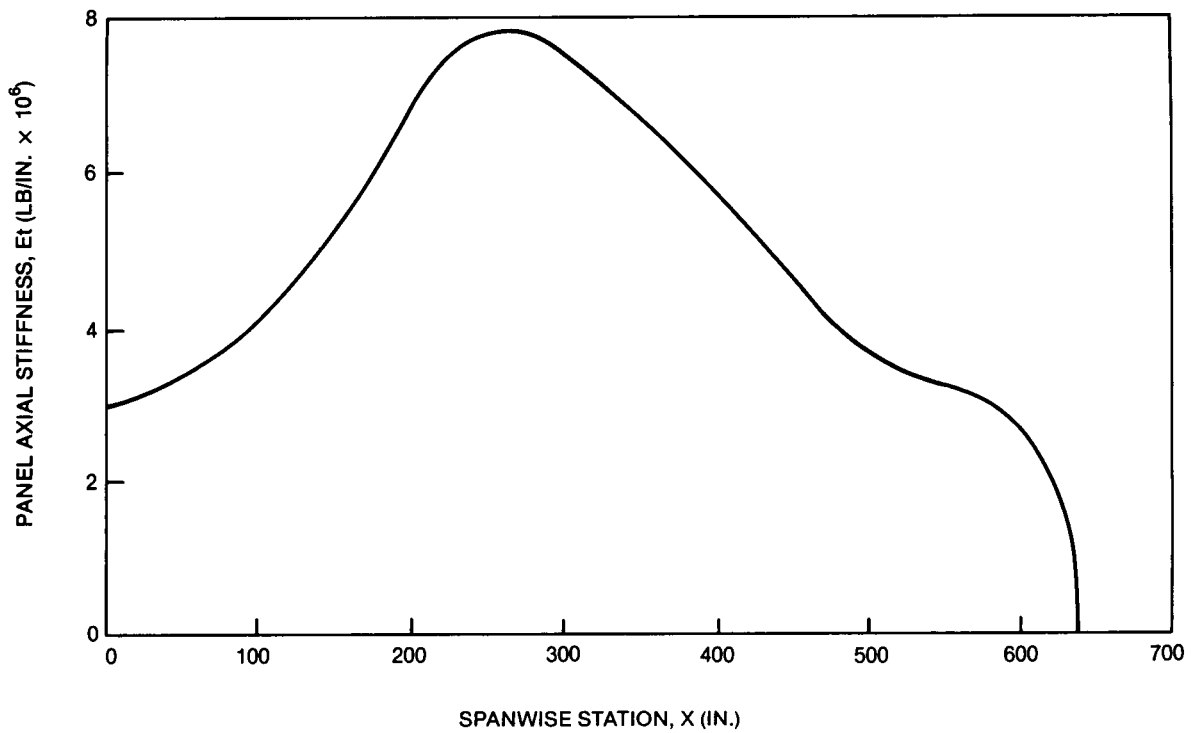
**Figure 7. Wing Box Extensional Stiffness Requirement**

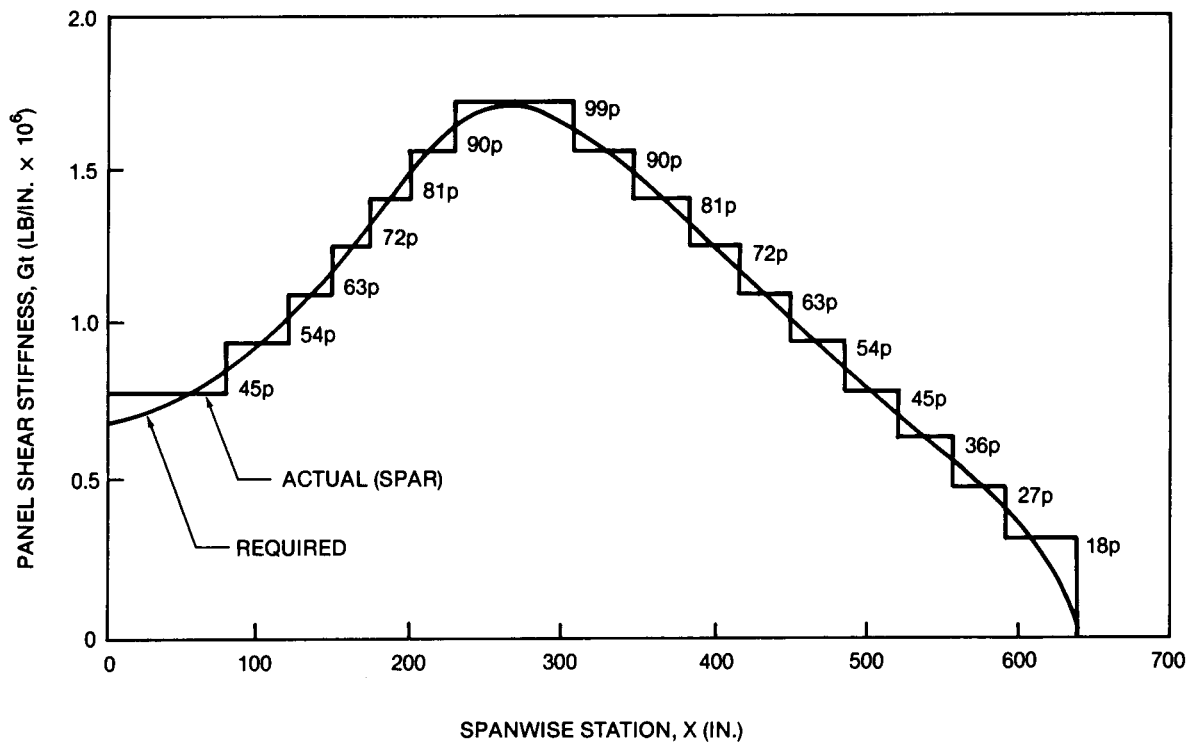
**Figure 8. Shear Stiffness Distribution**

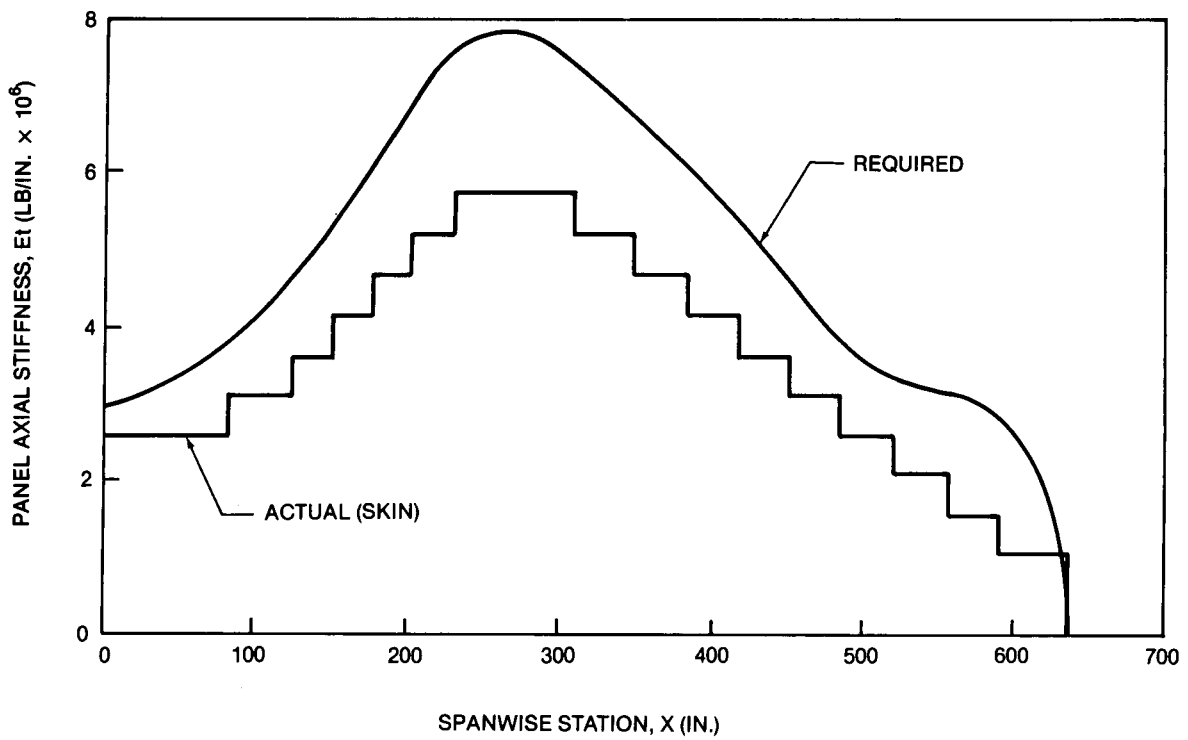
**Figure 9. Extensional Stiffness Distribution**

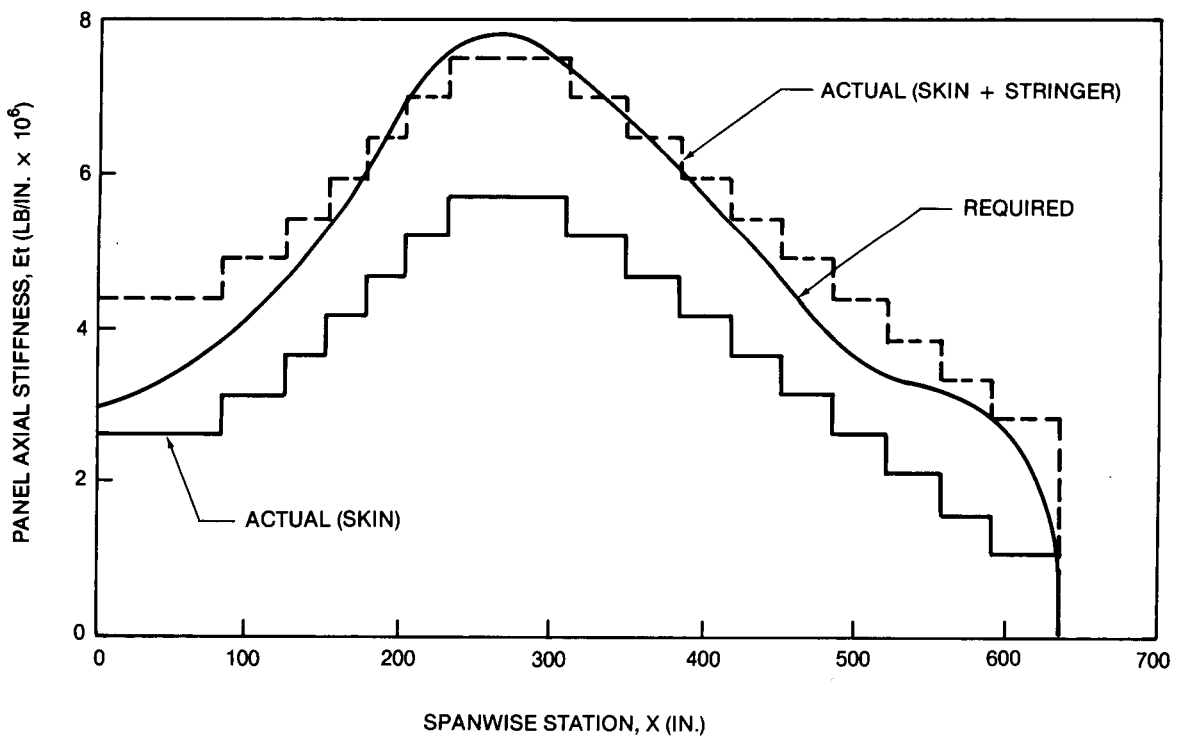
**Figure 10. Extensional Stiffness Distribution in Skin and Stringers (7-inch Pitch)**

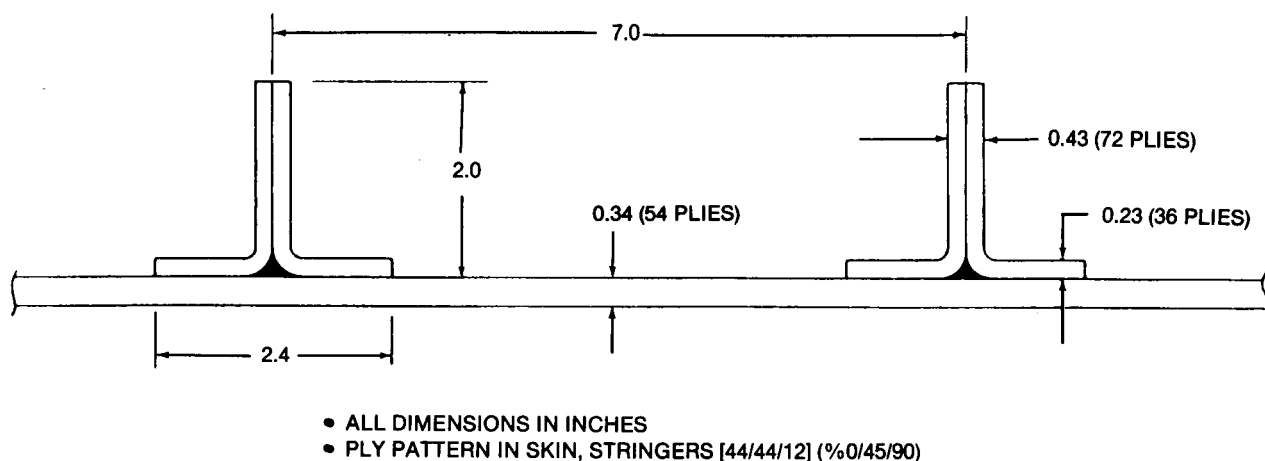
**Figure 11. Composite Wing Cover Panel Concept**

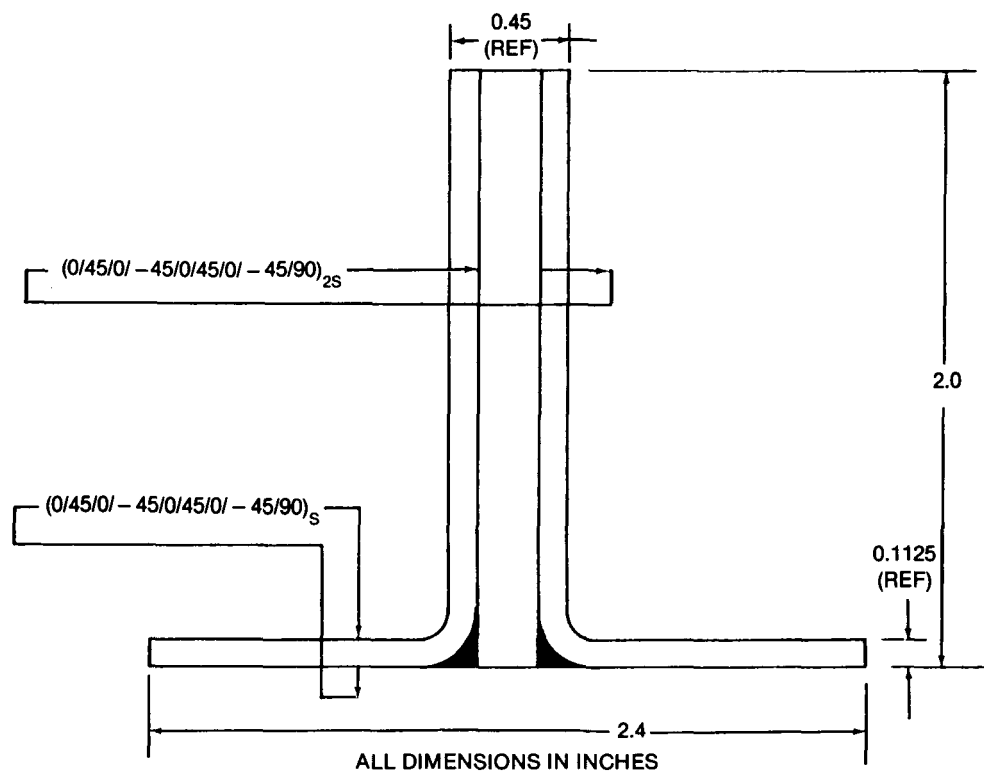
**Figure 12. Modified Concept for Blade Stringers**

merits of several different concepts. Initial studies were centered on a "soft skin" concept (i.e., low axial stiffness) for enhanced damage tolerance, similar to the approach developed and adopted by McCarty and Whitehead (Reference 2). However, the relatively low stiffness (EA) of these concepts resulted in a substantial weight penalty for the baseline wing structure. Thus, with the strain level limitations imposed for aileron effectivity and with some of the promising properties demonstrated by new material systems, a "hard skin" approach (i.e., high axial stiffness) was selected. The concept shown in Figure 11 represents the baseline wing cover panel design. Several stringer sections were considered, but the various concepts resulted in roughly equal cover panel weights for the stiffness-critical design while maintaining adequate resistance to local and general instabilities. The blade section stringer was selected on the basis of minimum complexity and lower manufacturing costs. The stringers were bonded to the wing skins for cost effectiveness. It was initially assumed that stringers would be secondarily bonded to the skin and that stitching or bolts would only be added when absolutely necessary. The bond line interface is subjected to transverse tension forces due to fuel pressure and other effects. It was found that severe impact loads caused the stringers to separate from the skin in some cases. This problem was resolved by modifying the stringer to incorporate thinner flanges, as shown in Figure 12.

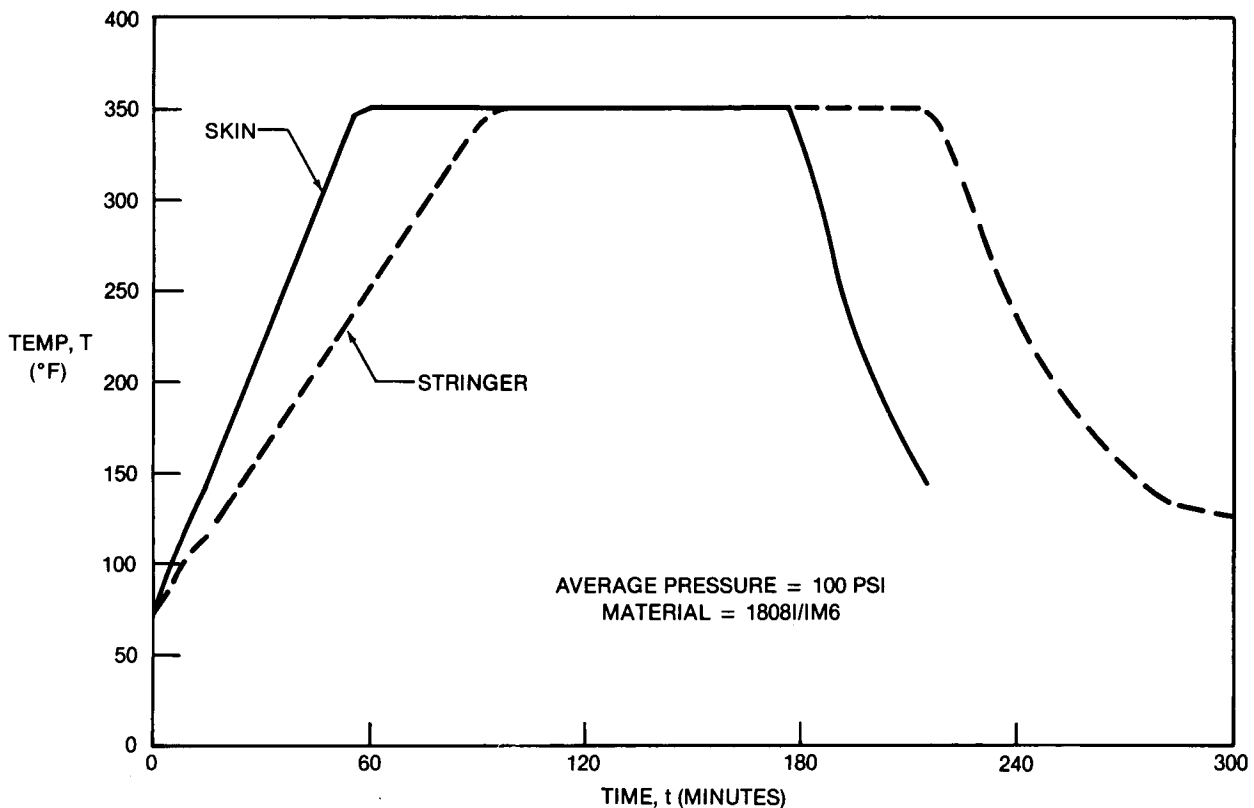
Figure 13. Typical Curing Cycle for Wing Skin and Stringer

Specimens were fabricated from 1808I/IM6 using the manufacturer's recommended procedures. A typical autoclave cure cycle is shown in Figure 13. Tooling for large composite wing parts was considered in terms of tooling materials and tool design and fabrication. Tool material selection was based on dimensional stability, durability, and a predictable tool life to establish acceptable recurring and overall costs.

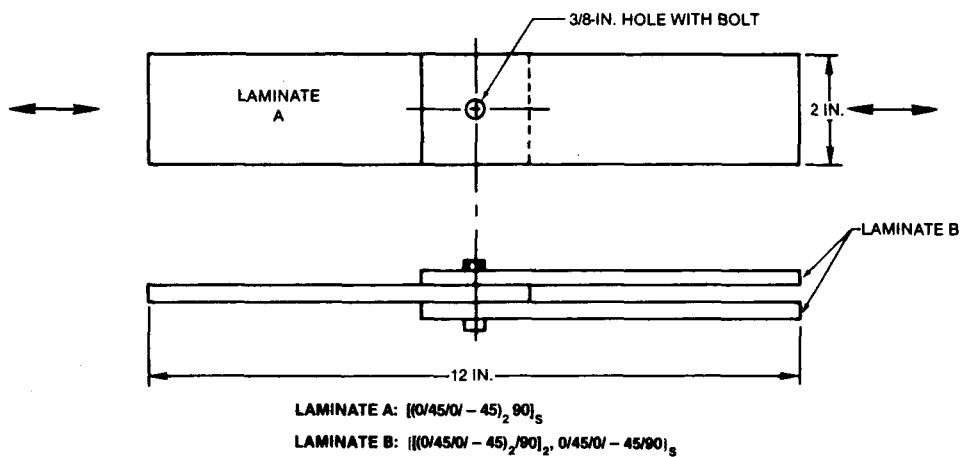
Figure 14. Tension and Compression Bearing Test Specimen

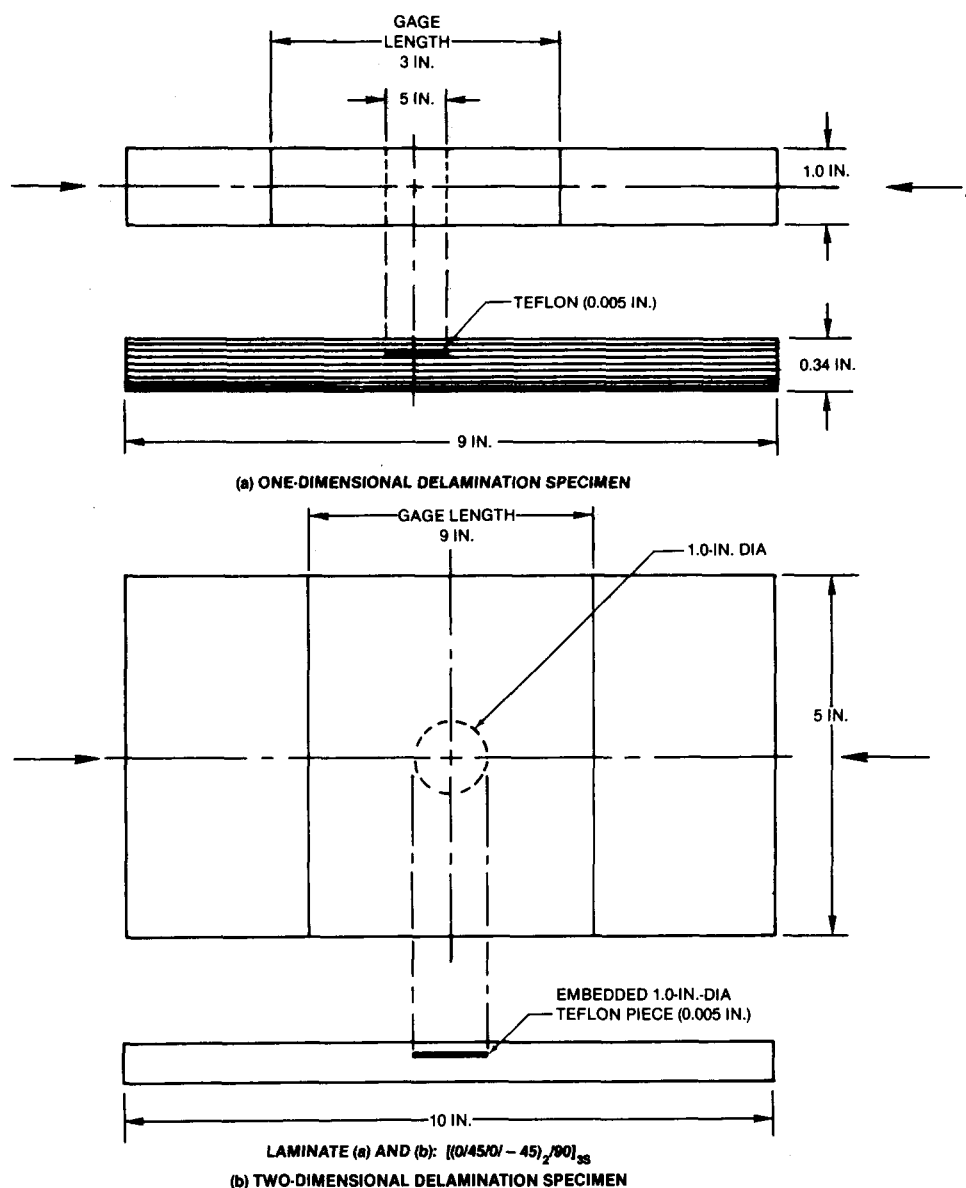
Figure 15. Compression-Delamination Specimens

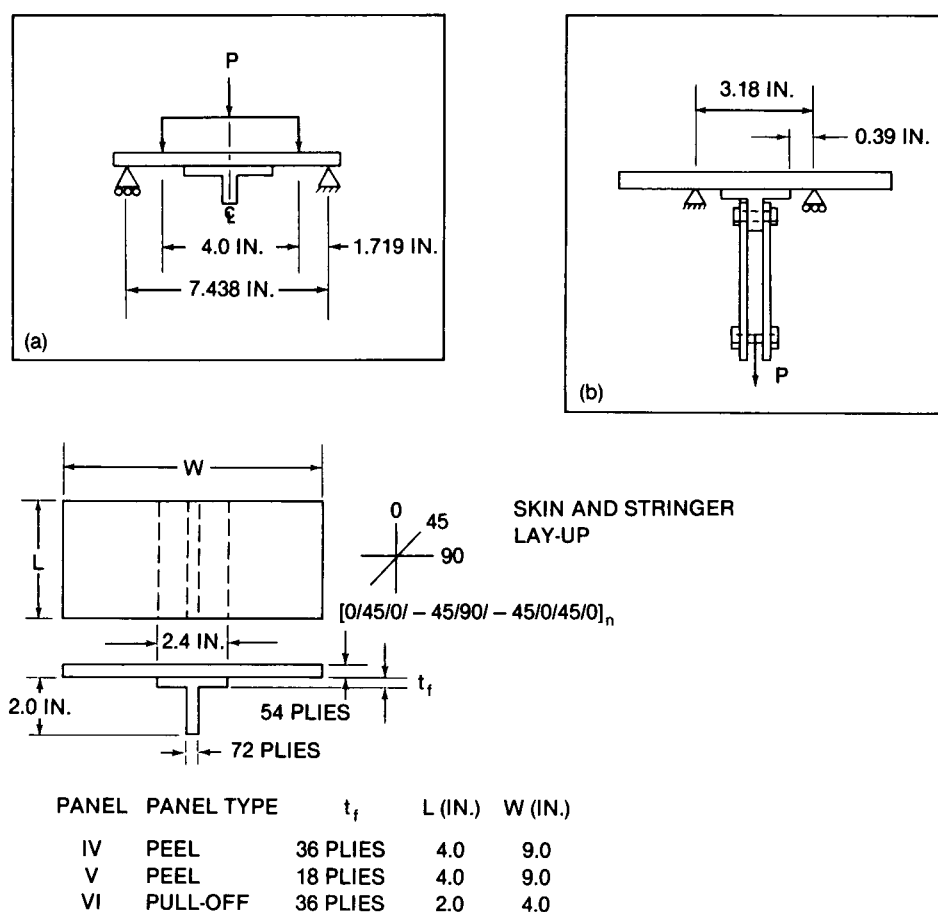
Figure 16. Peel (a) and Pull-Off (b) Specimen Configurations

Table 6 summarizes the development tests, and Figures 16, 17, and 18 show the dimensions (see Table 8) of test specimens. These trial impact, compressive strength, and residual compressive strength tests were designed to determine the residual strength for various impact damages. The peel stress tests gave interlaminar stresses in the adhesively bonded structure. The demonstration panel specimens are given in Table 7. These panels were fabricated and impact-damaged at Douglas, and then shipped to NASA where the compression-after-impact tests were conducted.

After evaluating several different concepts for this specimen, two configurations shown in Figure 16 were selected. The test consisted of a single-stringer panel, roughly square in plan view, which was loaded in a four-point bending with the loads applied on the skin side of the panel. The deflections induced under these loads were similar to those resulting from internal fuel tank pressures in the actual wing. The tensile stresses developed at the interface were not load-induced, but were deflection-induced, and resulted in critical peel stresses at the edge of the stringer flange.

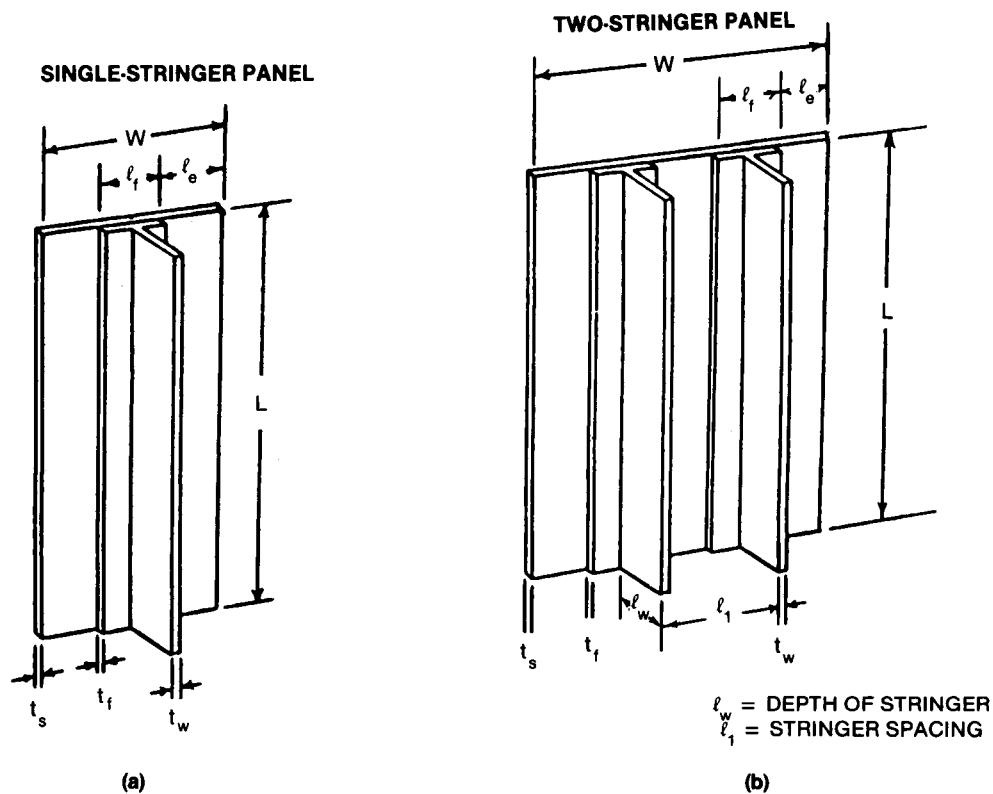
SEE TABLE 8 FOR DIMENSIONS

Figure 17. Trial Impact Specimens

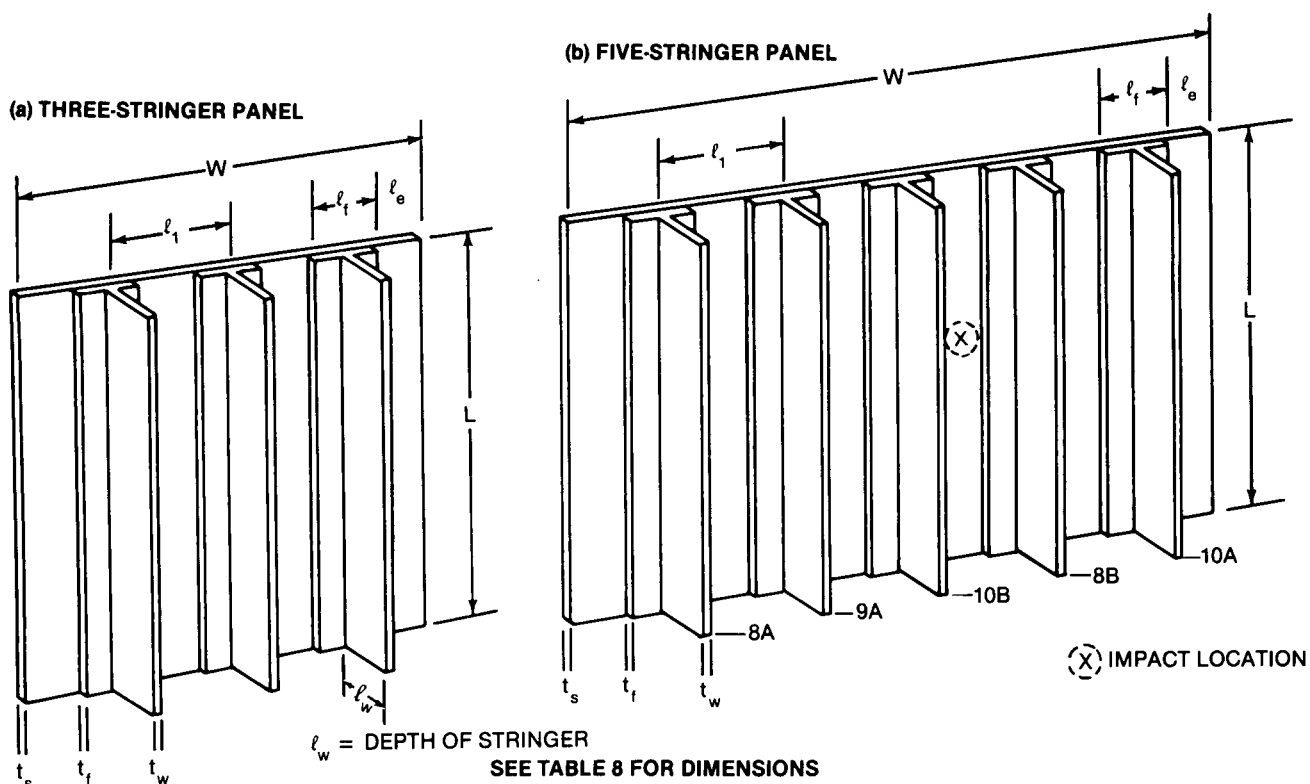
Figure 18. Damage Screening and Damage Tolerance Compression Panels

When the stringers were placed over the skin panel in order to bond them together, gaps of different sizes were found between the stringers and skin along the centerline normal to the stringers (see Figure 18b). The gap was 0.03 inch for stringer 8A, 0.018 inch for stringer 9A, 0.019 inch for stringer 10B, and 0.012 inch for stringer 10A. Such gaps at full pressure would produce areas of undesirable porosity in the bond line. A special nonadhering epoxy film, FM641, known as Verifilm Green has been developed to check for the presence of gaps at full pressure and temperature. A single ply of the 0.015-inch-thick FM641 was sandwiched between the two plies of 0.001-inch-thick Mylar. The usual bagging procedure was employed using the FM641 instead of the FM300.

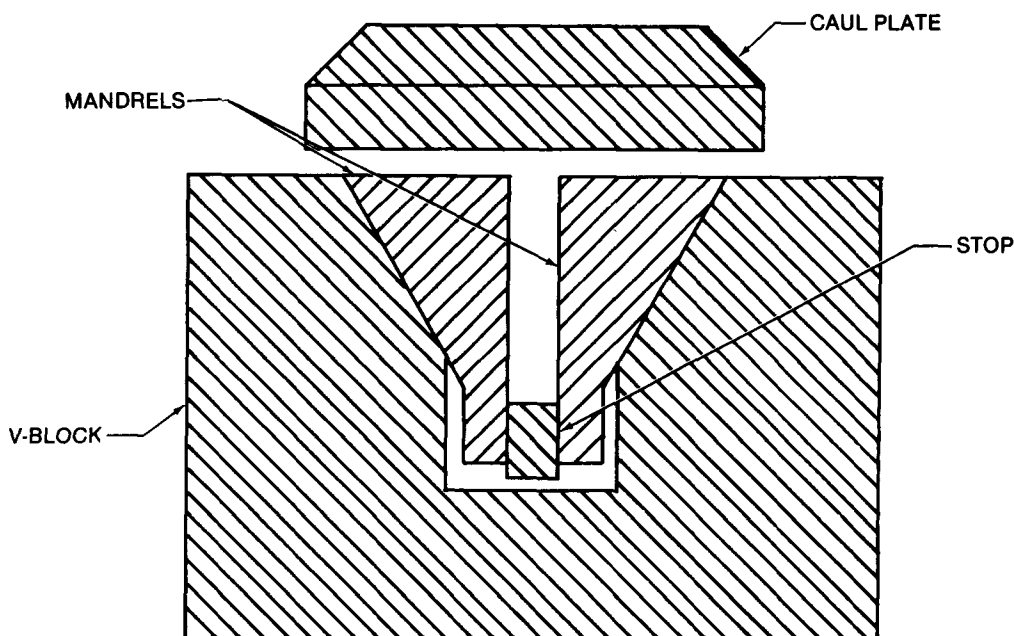
**Figure 19. Stringer Tooling Concept**

All the stringers for single-stringer and multistringers panels were fabricated using the above tooling concepts. The fabrication of 6-foot stringer tools for use in fabricating the large five-stringer cover panel specimens was completed, and the stringers were subsequently bonded to the skin panels. The nominal dimensions of all the stiffened panels are given in Table 8, and those of the compression test and trial impact panels are shown in Figure 17. Flanges were constructed from 36 plies of 1808I/IM6 material for

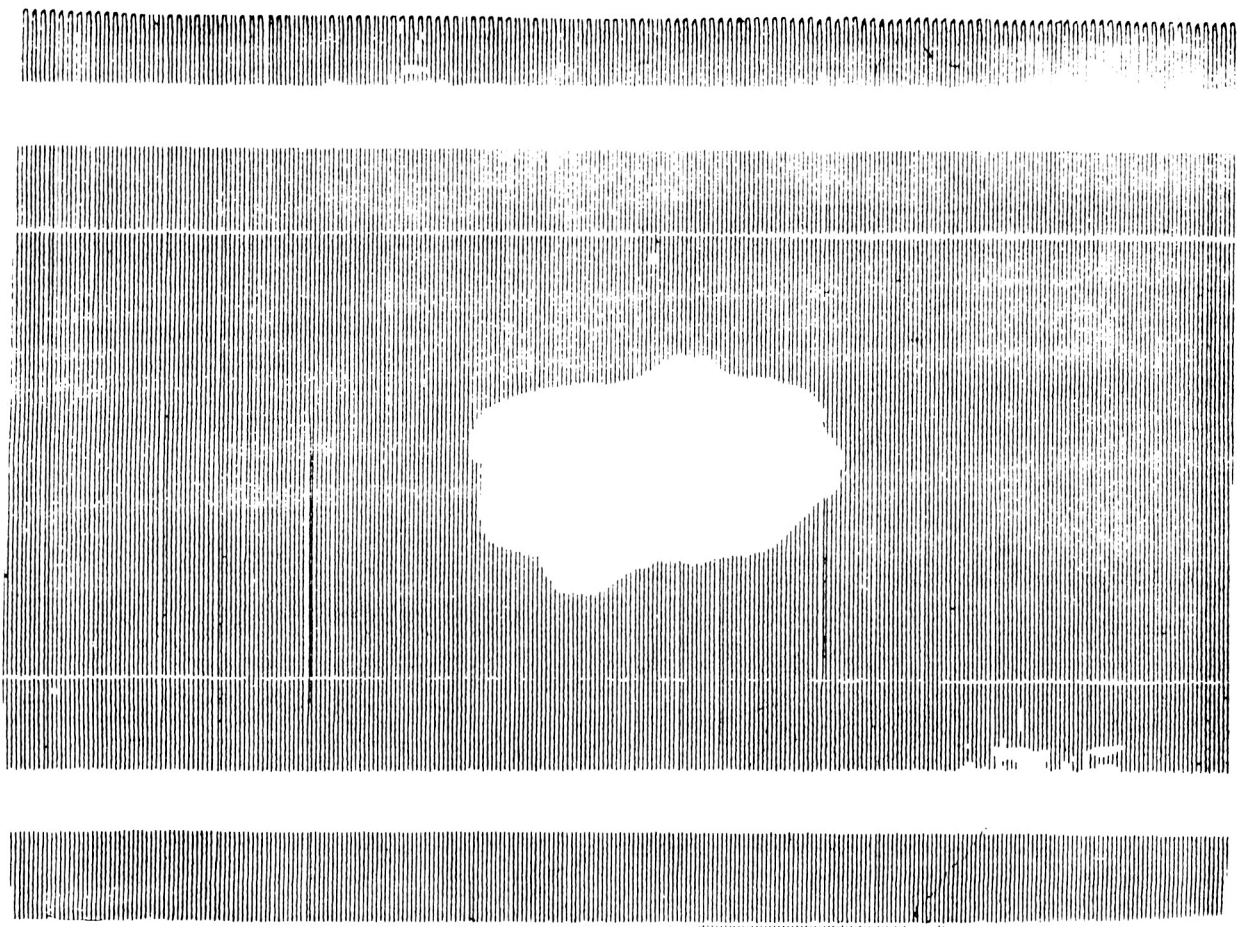
Figure 20. NDI of Panel D2 After Impact (Visible Damage — 100-ft-lb, 1/4-in. Impactor)

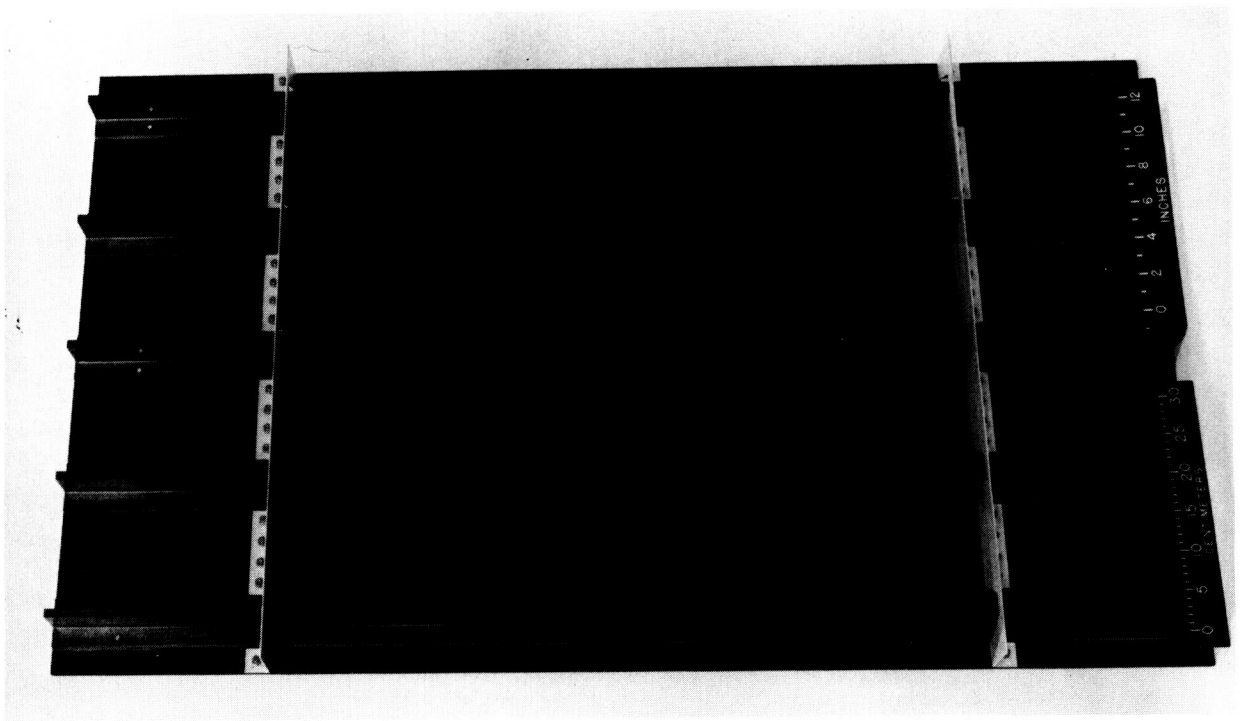
**Figure 21. Demonstration Panel (Five-Stringer Panel)**

Two five-stringer panels have been fabricated using the same cure cycle. The skin panels were made from a recently procured material with a thickness of 0.0083 inch per ply. These large panels, which were impact-damaged at Douglas, were compression-tested at NASA Langley. The test plan sent to NASA shows that one panel will have visible damage and the other will have discrete source impact damage at midbay. To achieve visible damage, several trial impact tests were conducted on several undamaged parts of already impacted two-stringer panels. Finally, both five-stringer panels were impacted at midbay with 100 ft-lb of impact energy using a 17-inch support span. No NDI-detectable damage was produced when the first panel was impacted with a 1-inch-diameter impactor. The second panel was impacted with a 1/4-inch-diameter impactor, and visible damage resulted. The C-scan for this panel is shown in Figure 20. Both panels were impacted using a 17-inch center support span to compare the

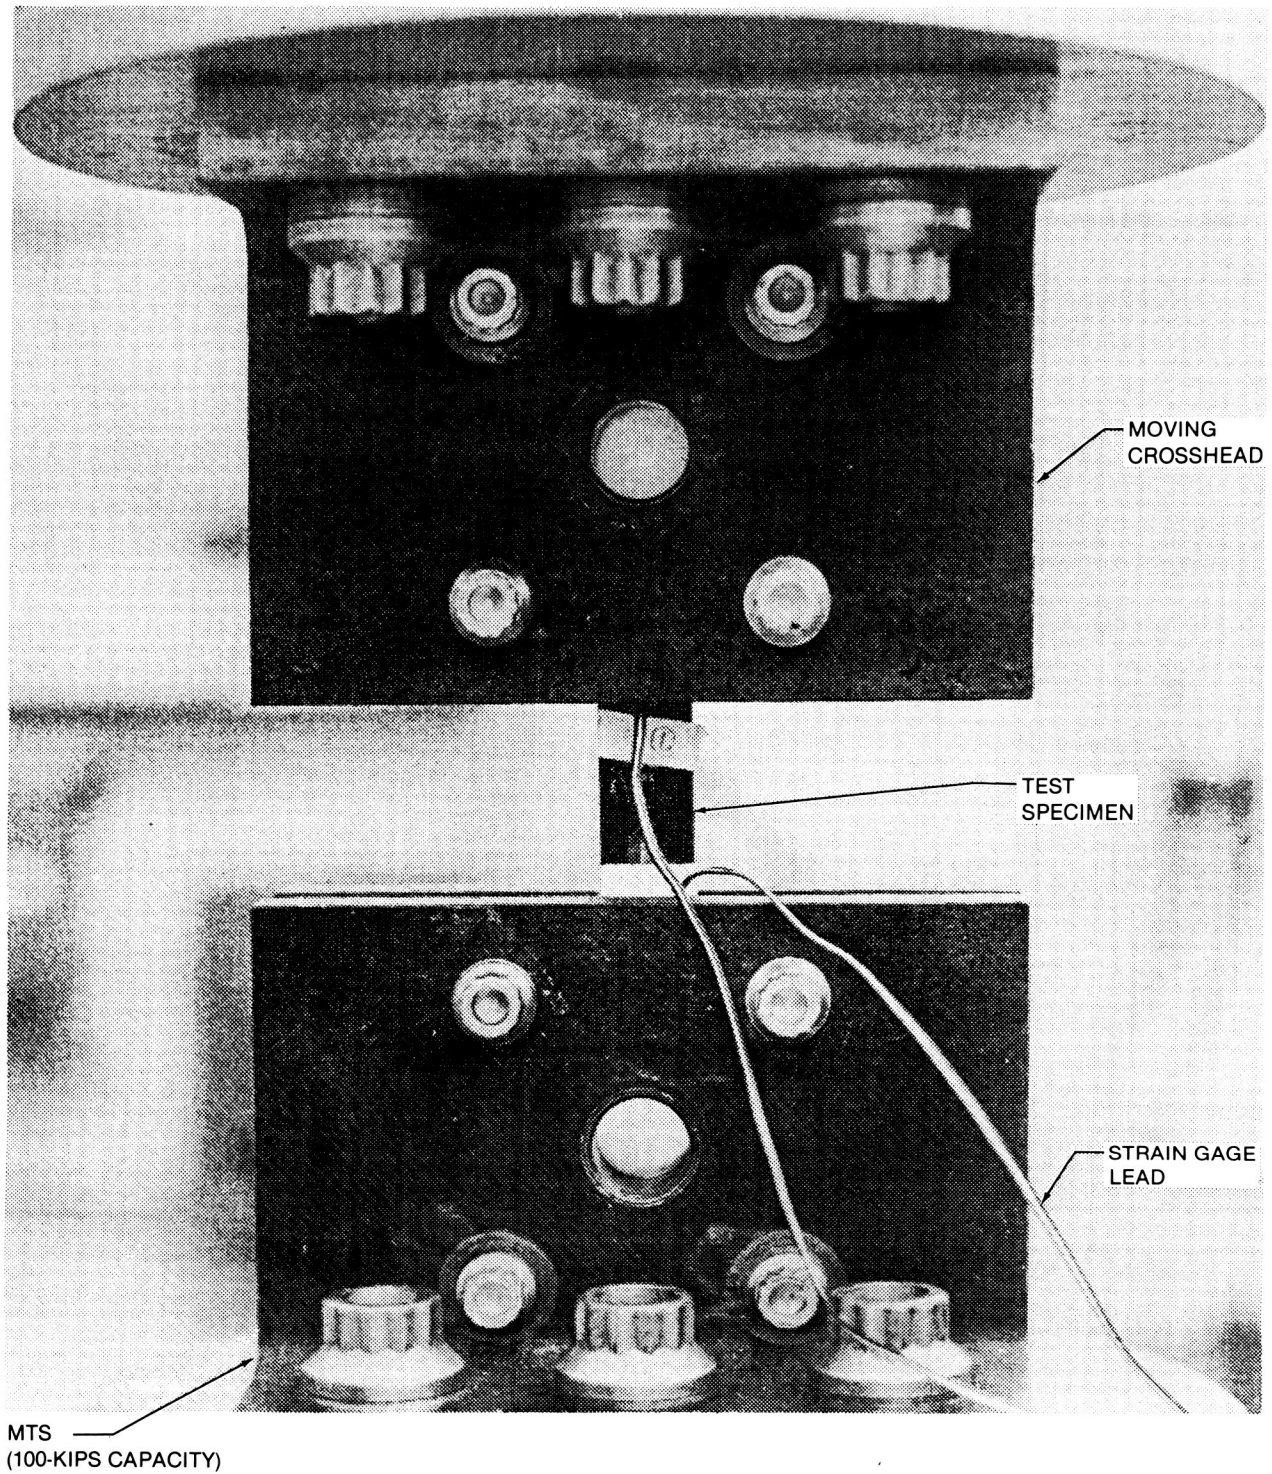
**Figure 22. One-Dimensional Delamination Coupon Test Setup**

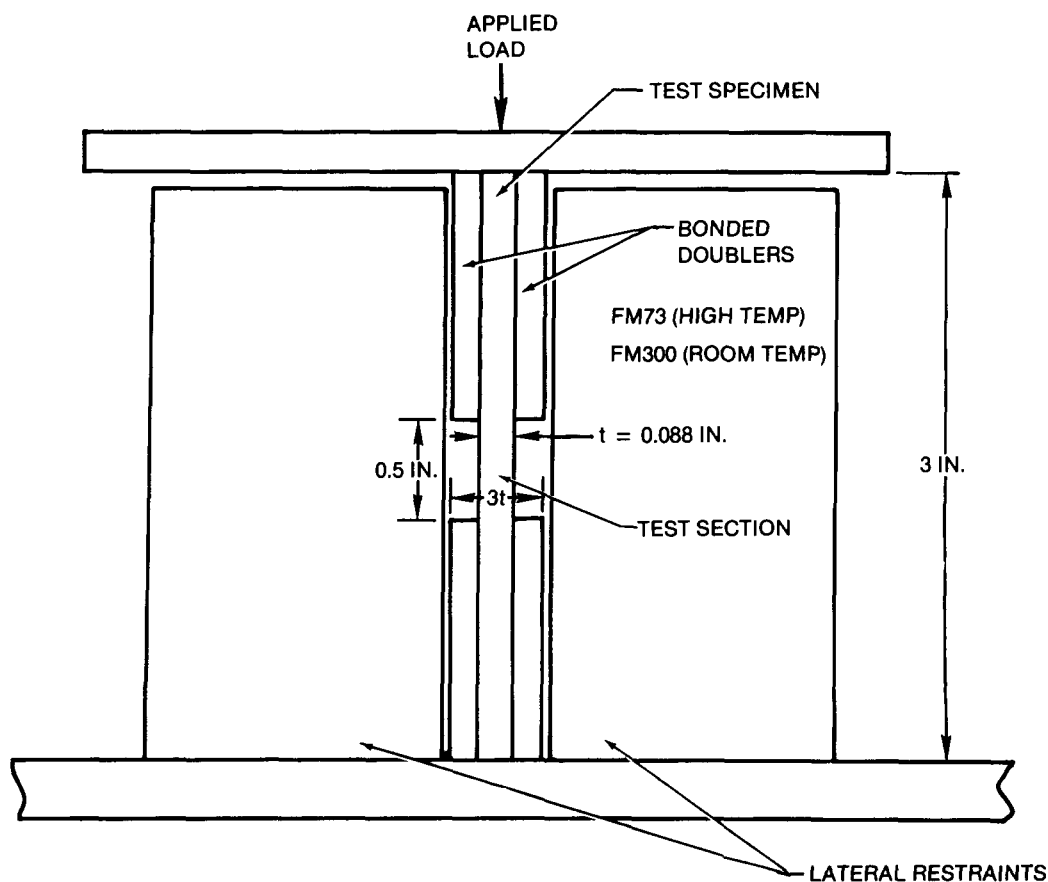
**Figure 23. Unnotched Compression Test Setup**

Two-dimensional compression delamination specimens were tested in the ST-1 (Reference 1) fixture with antibuckling plates. One-dimensional delamination tests were performed in a setup similar to that shown in Figure 23.
